ST. JAMES LAKE DAM

JEFFERSON COUNTY
NEW YORK

INVENTORY NO NY 779

PHASE I INSPECTION REPORT NATIONAL DAM SAFETY PROGRAM

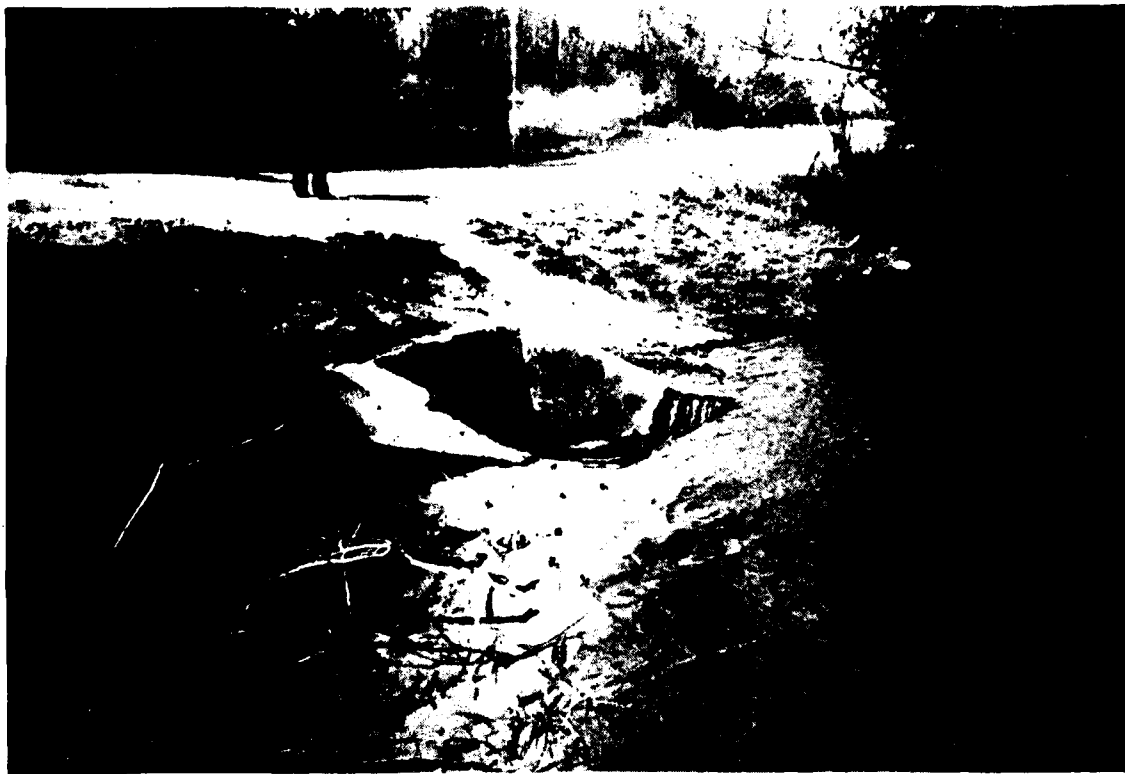
Overview of front of dam showing service spillway.
Dam does not have an emergency spillway or weir type
spillway.

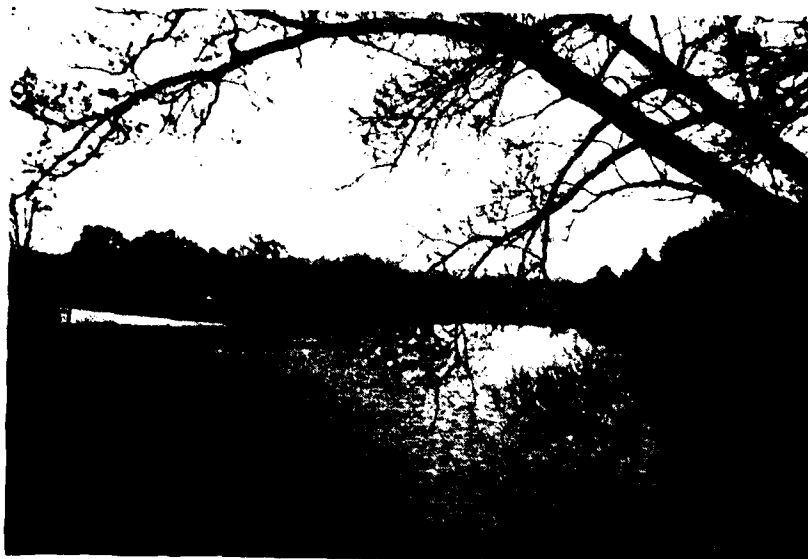
2. View of upstream reservoir.

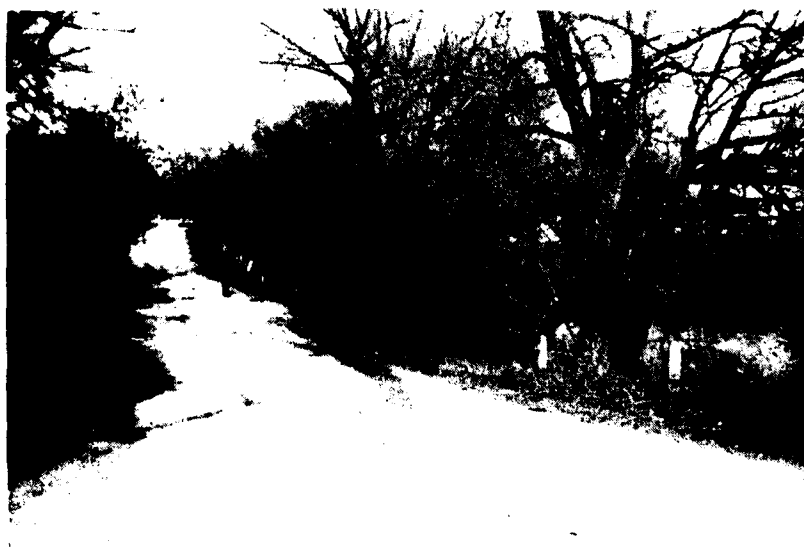
4. View of earthen road across top of dam. Ratio of width of dam to height of dam quite large.

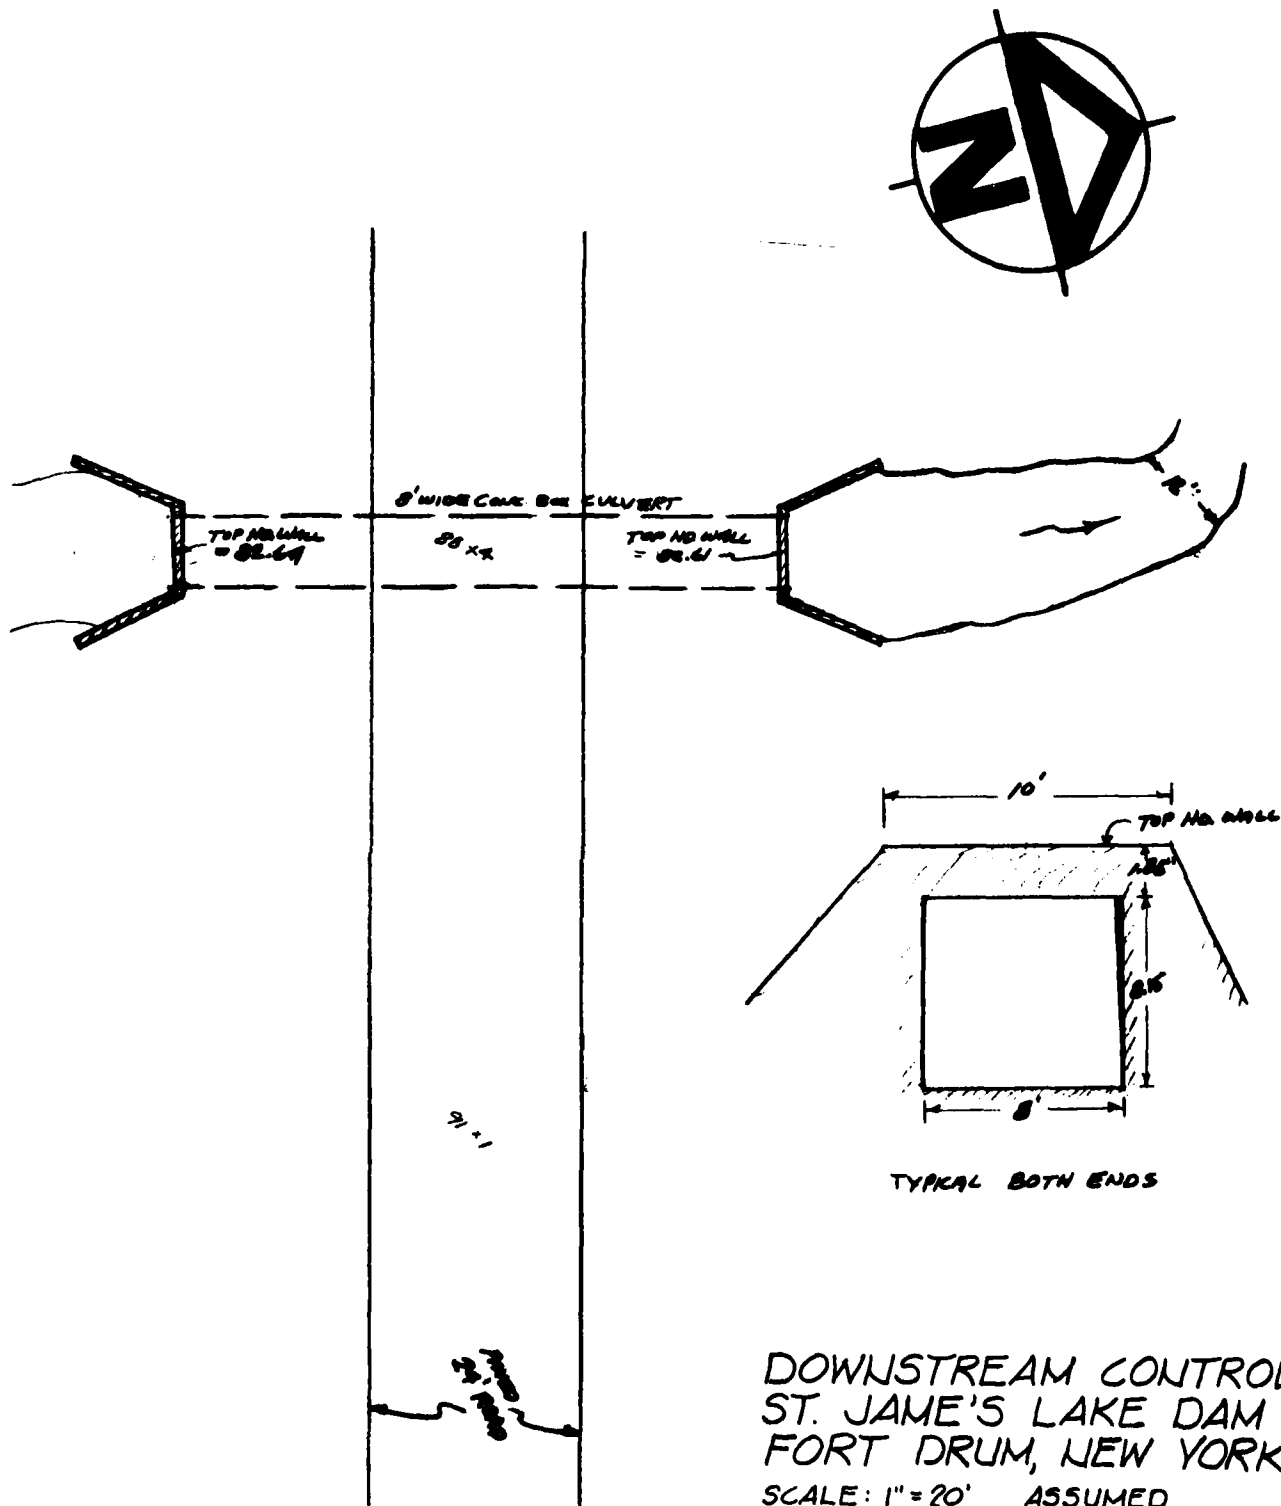
FIGURE 2

The downstream hazard is a lightly traveled road heading north out of the cantonment area. Should dam failure occur, this road would be overtopped to approximately the same depth of the dam overtopping.

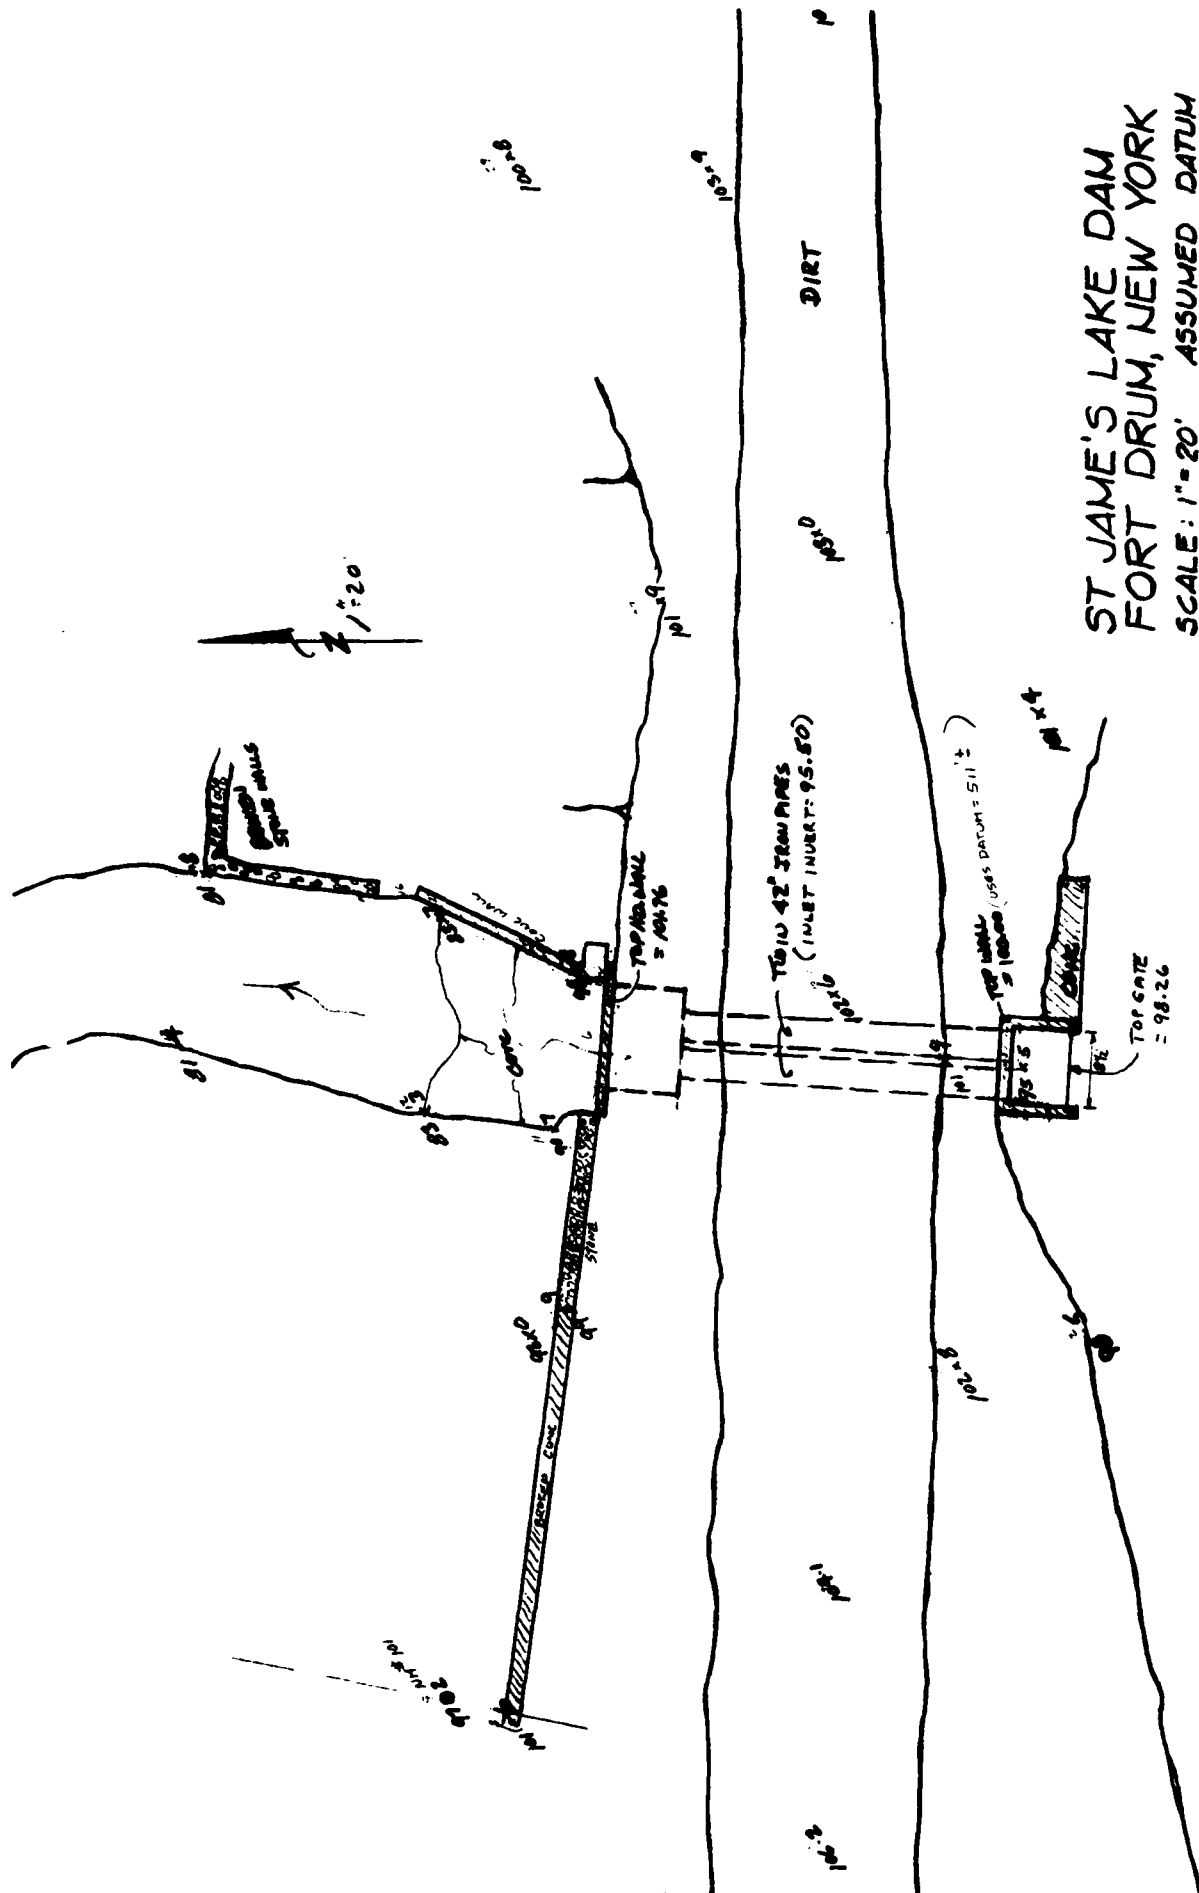
ST JAMES LAKE DAM
FORT DRUM, NEW YORK
SCALE: 1"=20' ASSUMED DATUM

The dam and spillway are shown in the Sketches prepared by Dale Engineering Company in Figure 3. The date of the construction of the dam is not known, nor are the materials of construction. The dam is apparently constructed of earth fill. The embankment is poorly maintained and large trees have grown on both the upstream and downstream slopes of the dam. Some trees had been cut on the downstream slope and the cuttings were left on the face of the dam. A masonry wall located just to the west of the downstream outlet is in deteriorated condition as is the apron on the principal spillway. Some seepage was noted just to the east of the principal spillway. Substantial flow was observed under the east wing wall of the outlet structure. No bank protection is provided on the upstream face of the dam.
